MARINE CASUALTY REPORT

GLOMAR JAVA SEA

CAPSIZING AND SINKING

MARINE BOARD OF INVESTIGATION REPORT

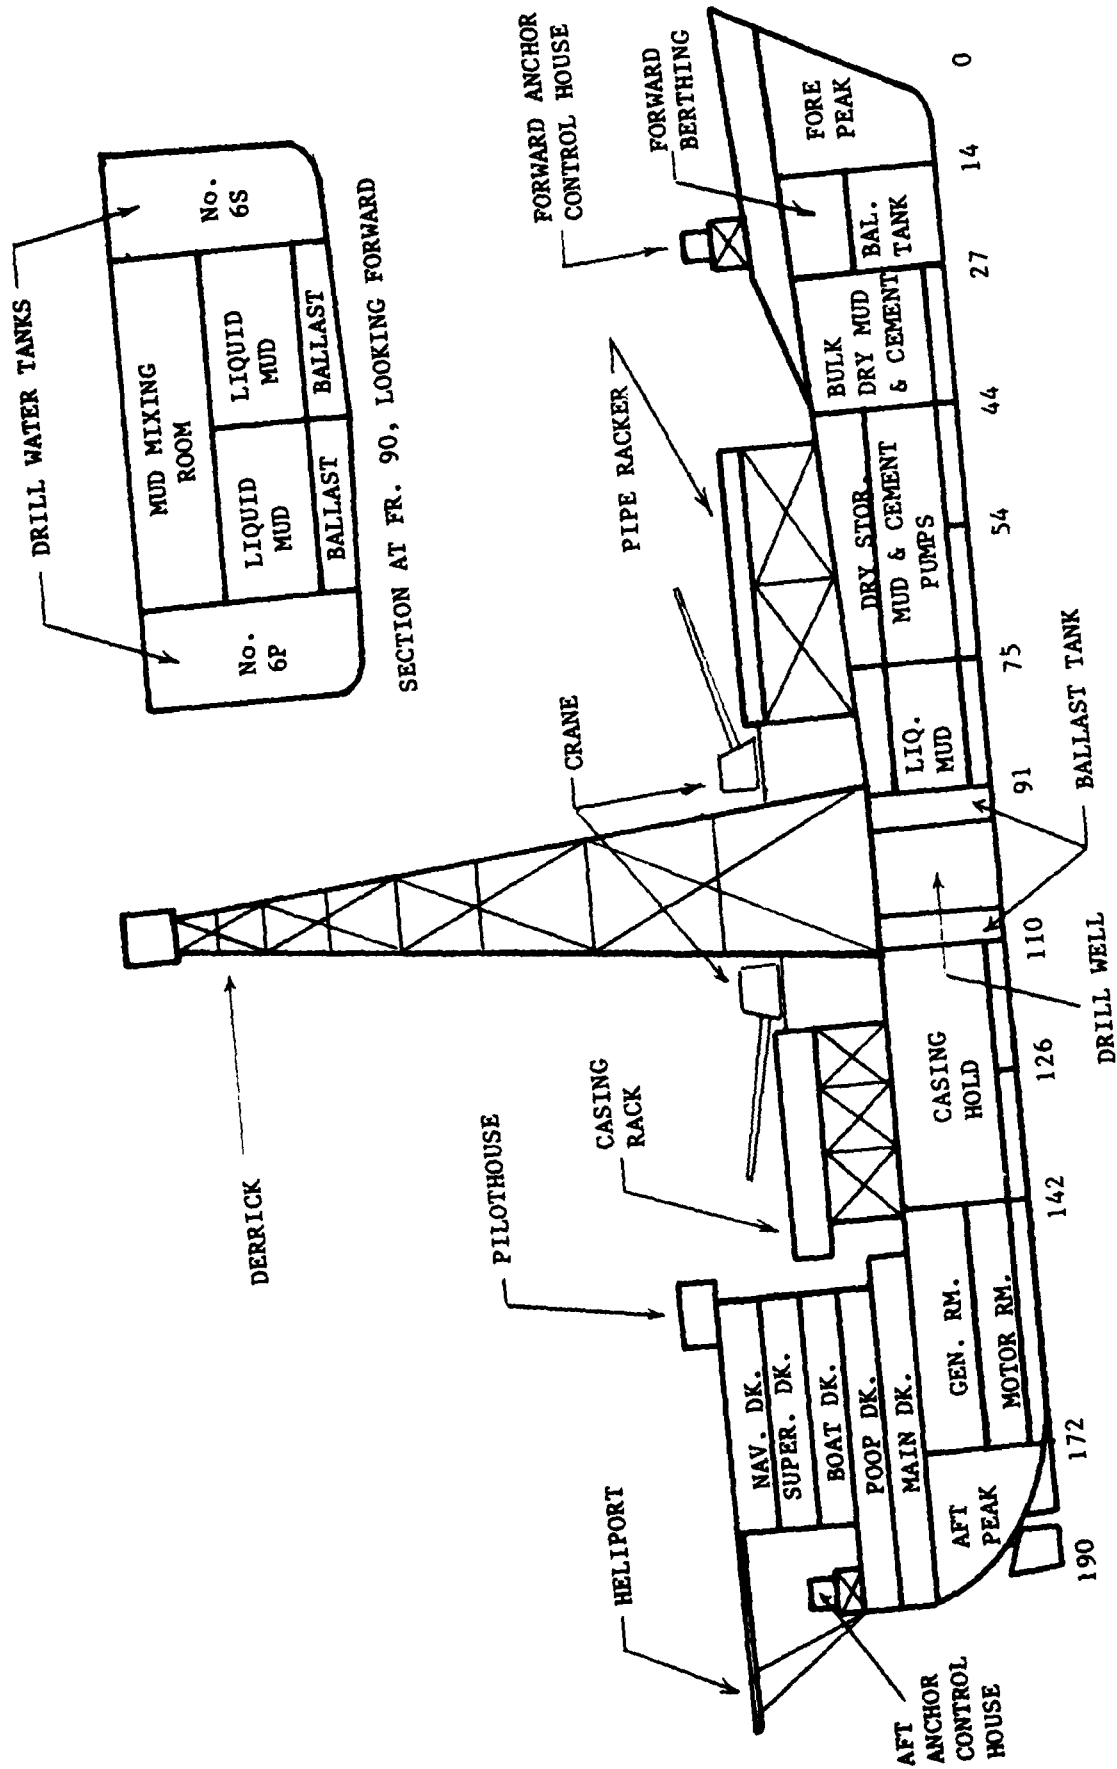
FIGURE 2: Drillship GLOMAR JAVA SEA, Inboard Profile

Above the main deck, aft, above the machinery spaces was a 5-level deckhouse topped by the pilothouse. Aft of the deckhouse cantilevered over the stern was the heliport. The main deck level of the house contained crew staterooms, change and shower rooms, the hospital, laundry, workshops, and the steward's storeroom. Aft of those spaces were the aft anchor chain lockers.

The poop deck (01) level contained the galley, messroom, freezer, and crew's lounge. Aft of those spaces were the aft anchor windlasses.

The boat deck (02) level contained crew staterooms including the Chief Engineer's room. The lifeboat davits and the aft anchor windlass control room were located on this deck.
